# Manhole Inspection Summary

Manhole # S11EE1005MH

**Location** Address: **TOWANDA AVE** Cross Street: **QUANTICO AVE**

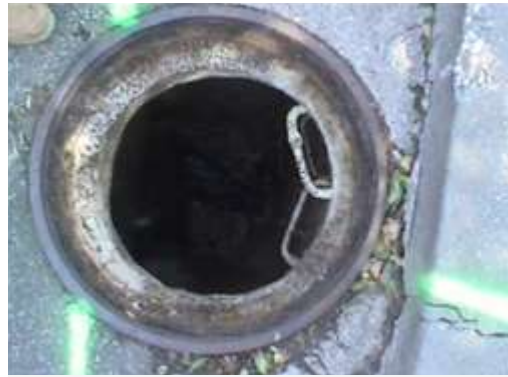
Top View

**Frame** Offset: **2** (in.) Condition: ☒ Sound ☐ Cracked ☐ Leaks

FRAME OFFSET

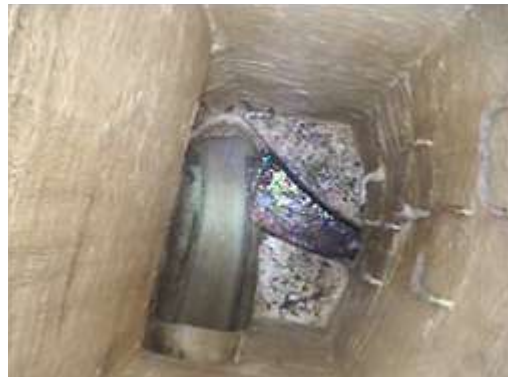
Defect 1

**Steps** Count: **9** Missing: **0** ☒ **Corroded**

CORRODED STEPS

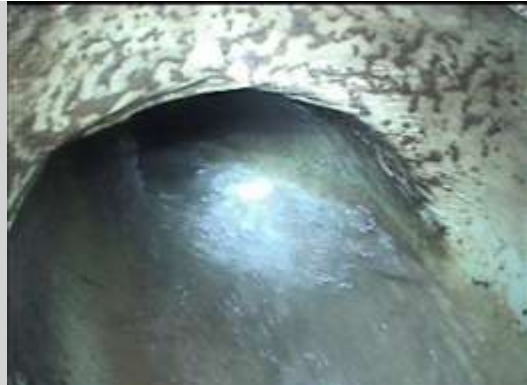
12 O'Clock Outflow

18 in. Circular Gravity Sewer  
Pipe Out @ 12 O'Clock

Pipe Height: **16.8** (in.) Rod and Bar (Angled)  
Pipe Material: **PVC** ☐ Pipe Lined  
Invert Depth: **16.15** (ft.) Flow Characteristics: **Turbulent**  
Deposits: ☒ None ☐ Mud ☐ Sludge ☐ Debris ☐ Grease  
Silt Depth: (in.) Deposits Extent:  
Infiltration: **None** Pipe Seal Cond: **Sound**

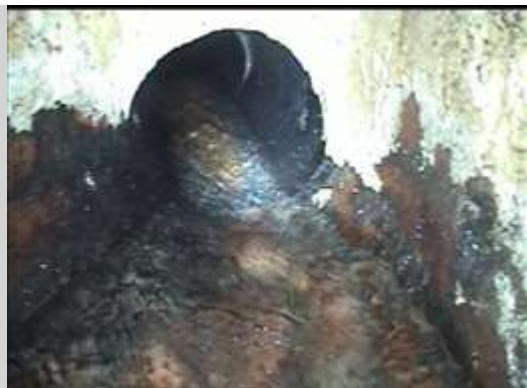
3 O'Clock Inflow

10 in. Circular Gravity Sewer  
Pipe In @ 3 O'Clock

Pipe Height: **10.8** (in.) Rod and Bar (Angled)  
Pipe Material: **Clay** ☐ Pipe Lined  
Invert Depth: **15.40** (ft.) Flow Characteristics: **Fast**  
Deposits: ☒ None ☐ Mud ☐ Sludge ☐ Debris ☐ Grease  
Silt Depth: (in.) Deposits Extent:  
Infiltration: **None** Pipe Seal Cond: **Sound**

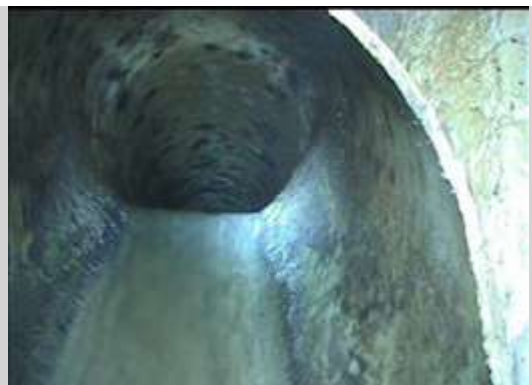
6 O'Clock Inflow

18 in. Circular Gravity Sewer  
Pipe In @ 6 O'Clock

Infiltration: **None** Pipe Seal Cond: **Sound**
